**Flood Control Project Maintenance  
Levee Inspections**

## Maintenance Issue Types Only, Levee Inspection Report By Mile - Spring 2017

### Reclamation District No. 0817 Carlin

Waterway	Bank	Unit Miles	Inspection Start/End	Inspector
Unit No. 01 South Dry Creek	Left	3.81	04/27/2017 04/27/2017	Sterling York

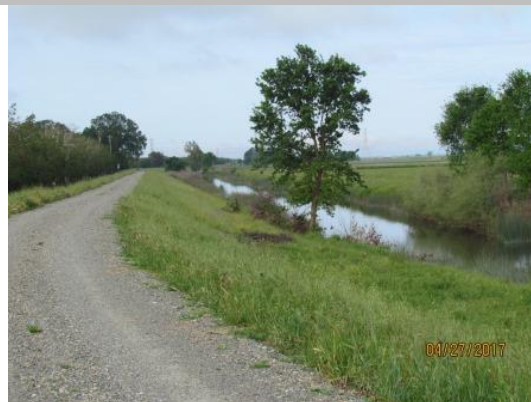
Photo 1 of 1 : SP\_2017\_RD0817\_12\_27\_20170428\_00017.jpg

LM Start	0.00	Rating **	M	Issue No.	27
LM End	3.81	Issue Type +	Ma	Location *	WS
Category	Earthen Levee			GPS Latitude/Longitude	
				Start	End
Item	Vegetation			38.984699 °	39.019645 °
				-121.506116 °	-121.454091 °
DWR ID	DWR_RD0817_01_s_2017_27				
Comment Code					
V1 : Control annual grass and weeds on the levee slopes and easements.					
Inspector Comment					
Annual vegetation needs to be maintained, Spring 2017.

View looking downstream of the annual vegetation that needs to be maintained, Spring 2017.

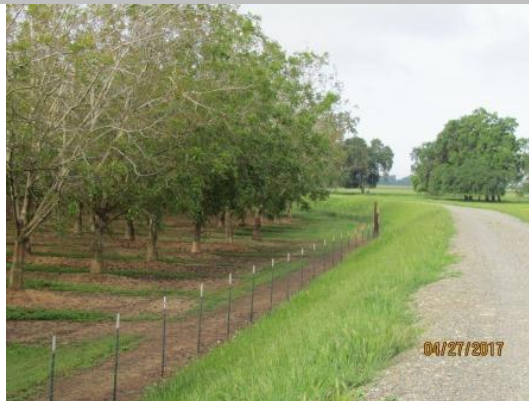
Photo 1 of 1 : SP\_2017\_RD0817\_12\_26\_20170428\_00018.jpg

View looking downstream of the annual vegetation that needs to be maintained, Spring 2017.

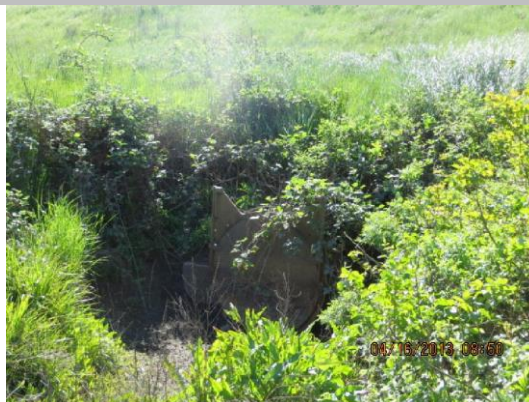
Photo 1 of 3 : UCIP\_SP\_2017\_42685\_19865.jpg

LM Start	0.29	Rating **	M	Issue No.	28
LM End	0.29	Issue Type +	Ma	Location *	LS
Category	Supplemental			GPS Latitude/Longitude	
				Start	End
Item	DWR UCIP LMA Responsibility			38.987813 °	38.987813 °
				-121.502963 °	-121.502963 °
DWR ID					
Comment Code					
Inspector Comment					
FS_ID:42685 DS_ID:18985 EP_NO: N/A Repair Type: Non-Urgent Crossing Status: Found UCIP Comments: Dense vegetation on waterward and landward slopes limit visual inspection of potential leaks along pipe alignment. Recommend having owner clear vegetation along slopes. FIELD_STRUCT_DESC: 48-inch corrugated metal drainpipe through levee, 23.3 feet below the crown. Flap gate on waterward end. FS Date: 4/16/2013

WS- pipe, flap gate in dense vegetation on berm

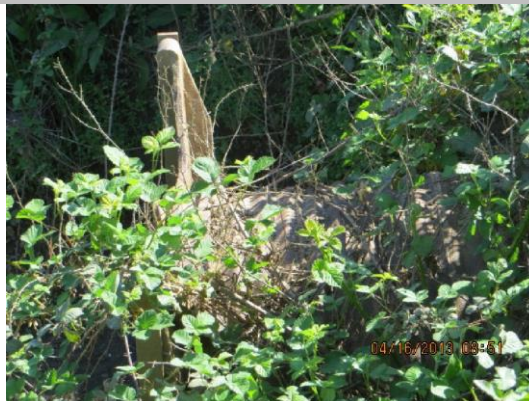
Photo 2 of 3 : UCIP\_SP\_2017\_42685\_19864.jpg

LM Start	0.29	Rating **	M	Issue No.	28 (cont)	
LM End	0.29	Issue Type +	Ma	Location *	LS	
Category	Supplemental			GPS Latitude/Longitude		
				Start	End	
Item	DWR UCIP LMA Responsibility			38.987813 °	38.987813 °	
				-121.502963 °	-121.502963 °	
DWR ID						
Comment Code						
Inspector Comment						
FS_ID:42685 DS_ID:18985 EP_NO: N/A Repair Type: Non-Urgent Crossing Status: Found UCIP Comments: Dense vegetation on waterward and landward slopes limit visual inspection of potential leaks along pipe alignment. Recommend having owner clear vegetation along slopes. FIELD_STRUCT_DESC: 48-inch corrugated metal drainpipe through levee, 23.3 feet below the crown. Flap gate on waterward end. FS Date: 4/16/2013

WS- CM pipe and flap gate

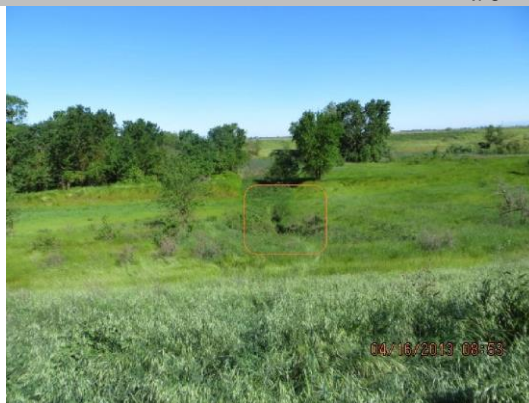
Photo 3 of 3 : UCIP\_SP\_2017\_42685\_19863.jpg

WS- dense vegetation on WS of the levee

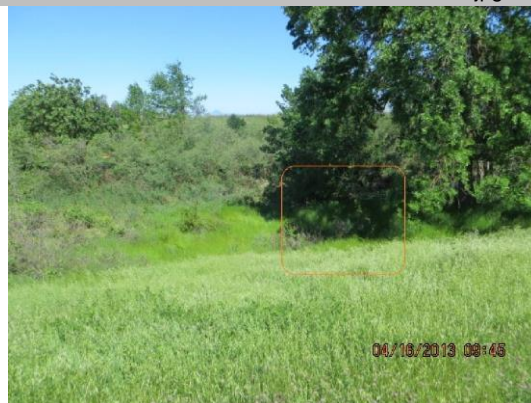
Photo 1 of 3 : UCIP\_SP\_2017\_41153\_19882.jpg

FS\_ID:41153  
DS\_ID:18987  
EP\_NO: N/A  
Repair Type: Non-Urgent  
Crossing Status: Found  
UCIP Comments: Damaged slide gate on WS of the levee. Need to contact owner to determine status of crossing. If crossing is no longer in use owner will need to contact CVFPB to comply with Title 23. Dense vegetation on waterward and landward slopes limit visual inspection of potential leaks along pipe alignment. Recommend having owner clear vegetation along slopes.  
FIELD\_STRUCT\_DESC: \*ABANDONED\* 18-inch corrugated metal drainpipe through levee, 14.9 feet below the crown. Slide gate on the waterward end. O&M Manual Sac 146, November 1962.  
FS Date: 4/16/2013

WS- overview of WS area

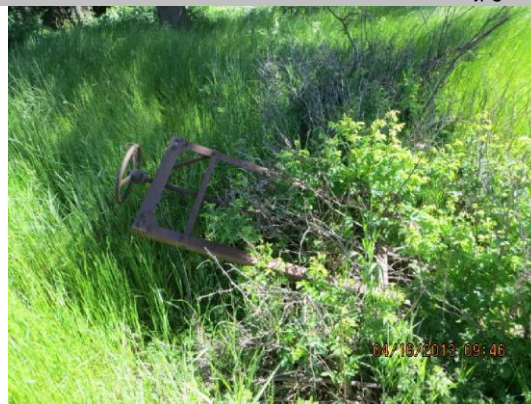
Photo 2 of 3 : UCIP\_SP\_2017\_41153\_19881.jpg

WS- closer look at damaged slide gate on WS

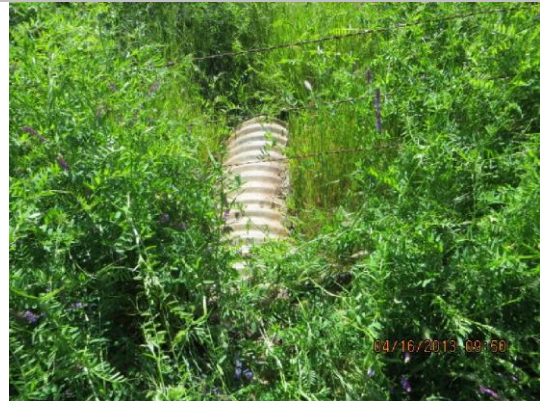
Photo 3 of 3 : UCIP\_SP\_2017\_41153\_19884.jpg

FS\_ID:41153  
DS\_ID:18987  
EP\_NO: N/A  
Repair Type: Non-Urgent  
Crossing Status: Found  
UCIP Comments: Damaged slide gate on WS of the levee. Need to contact owner to determine status of crossing. If crossing is no longer in use owner will need to contact CVFPB to comply with Title 23. Dense vegetation on waterward and landward slopes limit visual inspection of potential leaks along pipe alignment. Recommend having owner clear vegetation along slopes.  
FIELD\_STRUCT\_DESC: \*ABANDONED\* 18-inch corrugated metal drainpipe through levee, 14.9 feet below the crown. Slide gate on the waterward end. O&M Manual Sac 146, November 1962.  
FS Date: 4/16/2013

LS- CMP on toe of the levee.

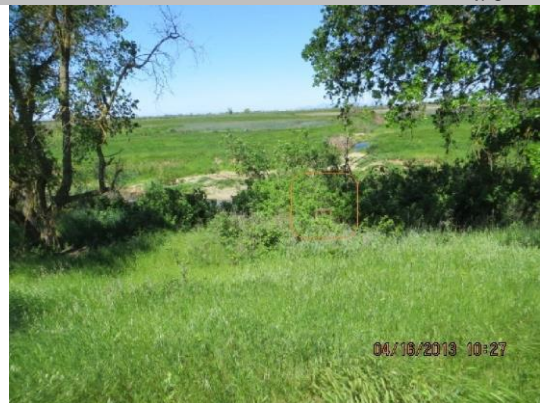
Photo 1 of 3 : UCIP\_SP\_2017\_41157\_19892.jpg

FS\_ID:41157  
DS\_ID:18988  
EP\_NO: N/A  
Repair Type: Non-Urgent  
Crossing Status: Found  
UCIP Comments: A buried slide gate on WS of the levee. Need to contact owner to determine status of crossing. If crossing is no longer in use owner will need to contact CVFPB to comply with Title 23. Dense vegetation on waterward and landward slopes limit visual inspection of potential leaks along pipe alignment. Recommend having owner clear vegetation along slopes.  
FIELD\_STRUCT\_DESC: \*ABANDONED\* 18-inch corrugated metal drainpipe through the levee, 14.9 feet below the crown. Slide gate on the waterward end. O&M Manual Sac 146, November 1962.  
FS Date: 4/16/2013

WS- overview of WS berm

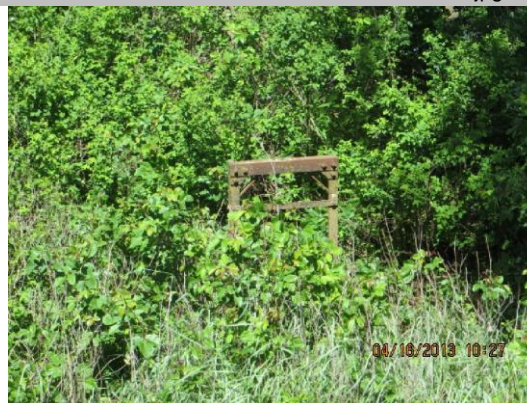
Photo 2 of 3 : UCIP\_SP\_2017\_41157\_19891.jpg

FS\_ID:41157  
DS\_ID:18988  
EP\_NO: N/A  
Repair Type: Non-Urgent  
Crossing Status: Found  
UCIP Comments: A buried slide gate on WS of the levee. Need to contact owner to determine status of crossing. If crossing is no longer in use owner will need to contact CVFPB to comply with Title 23. Dense vegetation on waterward and landward slopes limit visual inspection of potential leaks along pipe alignment. Recommend having owner clear vegetation along slopes.  
FIELD\_STRUCT\_DESC: \*ABANDONED\* 18-inch corrugated metal drainpipe through the levee, 14.9 feet below the crown. Slide gate on the waterward end. O&M Manual Sac 146, November 1962.  
FS Date: 4/16/2013

WS- slide gate

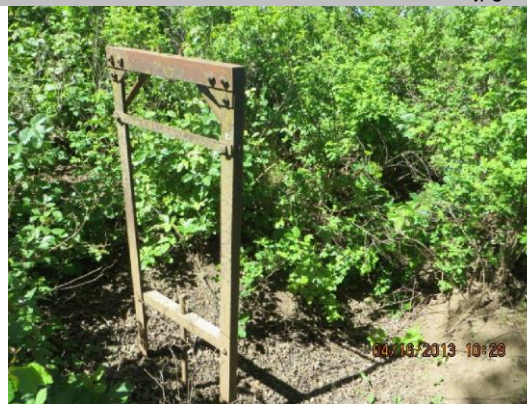
Photo 3 of 3 : UCIP\_SP\_2017\_41157\_19890.jpg

WS- buried slide gate

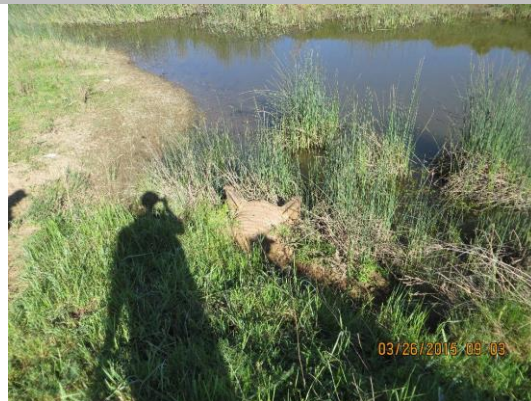
Photo 1 of 3 : UCIP\_SP\_2017\_43946\_73422.jpg

LM Start	2.96	Rating **	M	Issue No.	47
LM End	2.96	Issue Type +	Ma	Location *	LS
Category	Supplemental			GPS Latitude/Longitude	
				Start	End
Item	DWR UCIP LMA Responsibility			39.012552 °	39.012552 °
				-121.466538 °	-121.466538 °
DWR ID					
Comment Code					
Inspector Comment					
FS_ID:43946 DS_ID:18992 EP_NO: N/A Repair Type: Non-Urgent Crossing Status: Found UCIP Comments: Flapgate in closed position, but blocked from operation on WS toe. Pipe appears abandoned and should be verified as having been done so properly. FIELD_STRUCT_DESC: 36-inch corrugated metal drainpipe through the levee, 13.7-feet below the crown. Flap gate on the waterward end. O&M Manual Sac 146, November 1962. FS Date: 3/26/2015

Pipe and flapgate visible on WS toe.

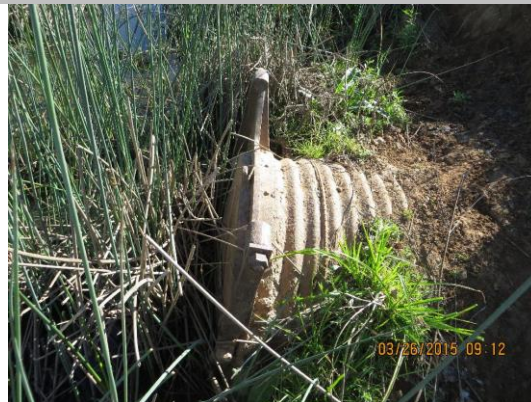
Photo 2 of 3 : UCIP\_SP\_2017\_43946\_73421.jpg

Pipe and flapgate visible on WS toe.

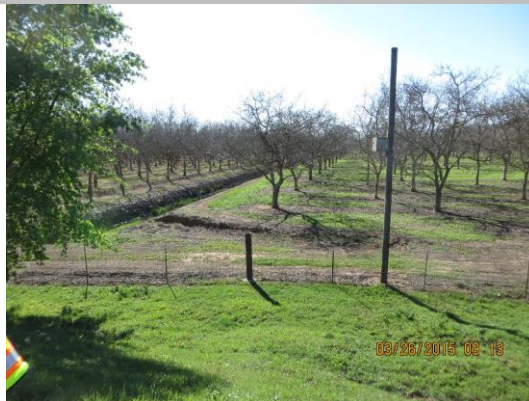
Photo 3 of 3 : UCIP\_SP\_2017\_43946\_73420.jpg

LM Start	2.96	Rating **	M	Issue No.	47 (cont)
LM End	2.96	Issue Type +	Ma	Location *	LS
Category	Supplemental			GPS Latitude/Longitude	
				Start	End
Item	DWR UCIP LMA Responsibility			39.012552 °	39.012552 °
				-121.466538 °	-121.466538 °
DWR ID					
Comment Code					
Inspector Comment					
FS_ID:43946 DS_ID:18992 EP_NO: N/A Repair Type: Non-Urgent Crossing Status: Found UCIP Comments: Flapgate in closed position, but blocked from operation on WS toe. Pipe appears abandoned and should be verified as having been done so properly. FIELD_STRUCT_DESC: 36-inch corrugated metal drainpipe through the levee, 13.7-feet below the crown. Flap gate on the waterward end. O&M Manual Sac 146, November 1962. FS Date: 3/26/2015

LS of pipe buried but alignment would place LS outlet just left of telephone pole on LS toe.

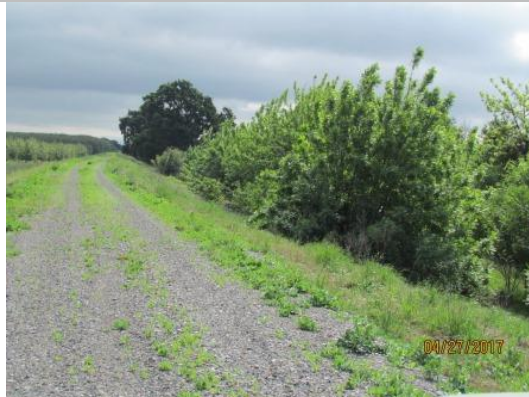
Photo 1 of 1 : SP\_2017\_RD0817\_13\_14\_20170428\_00022.jpg

View looking upstream of the annual vegetation that needs to be maintained, Spring 2017.

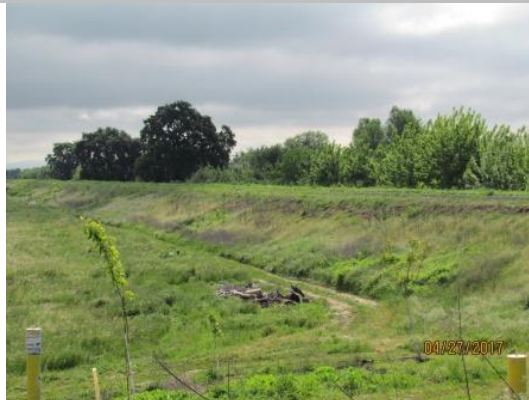
Photo 1 of 1 : SP\_2017\_RD0817\_13\_13\_20170428\_00021.jpg

LM Start	0.03	Rating **	M	Issue No.	13
LM End	3.86	Issue Type +	Ma	Location *	LS
Category	Earthen Levee			GPS Latitude/Longitude	
				Start	End
Item	Vegetation			38.984354 °	38.993400 °
				-121.505749 °	-121.437366 °
DWR ID	DWR_RD0817_02_f_2016_13				
Comment Code					
V1 : Control annual grass and weeds on the levee slopes and easements.					
Inspector Comment					
Annual grass needs to be maintained, Spring 2017.

View looking upstream of the annual vegetation that needs to be maintained, Spring 2017.

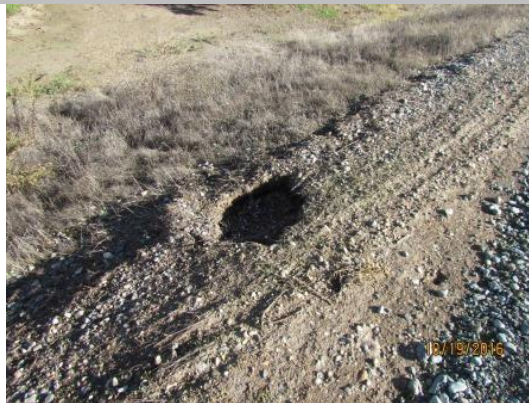
Photo 1 of 1 : SP\_2017\_RD0817\_13\_15\_20170316\_00007.jpg

View of a sink hole were old stump was. This needs to be backfilled and compacted. Fall 2016.

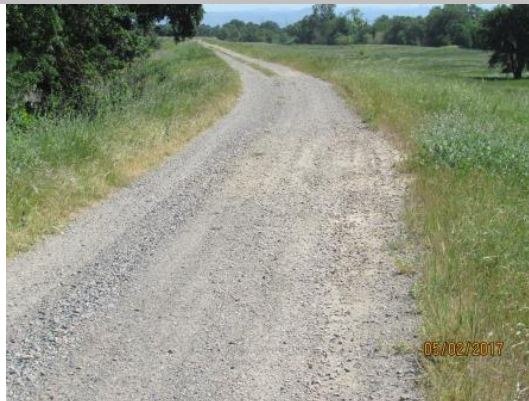
Photo 1 of 1 : SP\_2017\_RD0817\_14\_11\_20170503\_00036.jpg

View looking upstream of typical bare spots on the levee crown that need more aggregate base, Spring 2017.

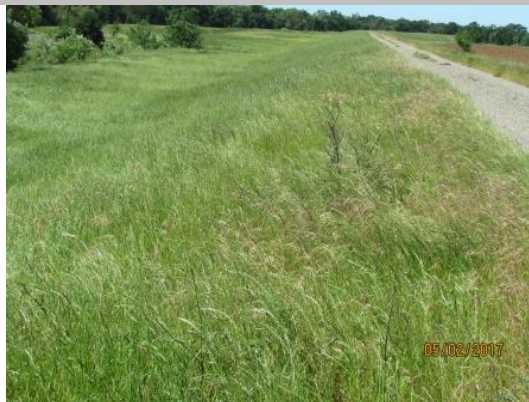
Photo 1 of 2 : SP\_2017\_RD0817\_14\_17\_20170503\_00033.jpg

LM Start	0.25	Rating **	M	Issue No.	17
LM End	1.27	Issue Type +	Ma	Location *	WS
Category	Earthen Levee			GPS Latitude/Longitude	
				Start	End
Item	Vegetation			38.987626 °	38.996896 °
				-121.506567 °	-121.491926 °
DWR ID	DWR_RD0817_03_f_2016_17				
Comment Code					
V1 : Control annual grass and weeds on the levee slopes and easements.					
Inspector Comment					
Annual grasses need to be maintained. Spring 2017

View of annual grasses that need to be maintained on the waterside looking downstream. Spring 2017.

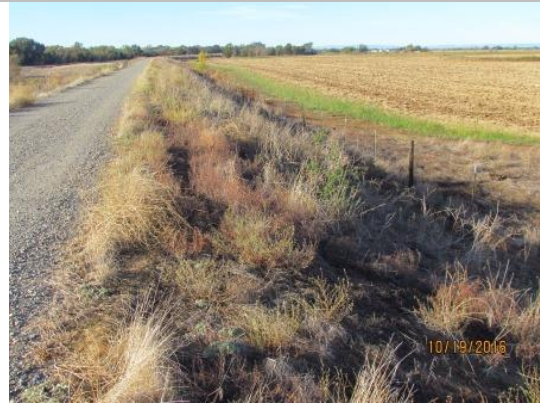
Photo 2 of 2 : SP\_2017\_RD0817\_14\_16\_20170316\_00008.jpg

View of annual grasses that need to be maintained on the landside looking downstream. Fall 2016.

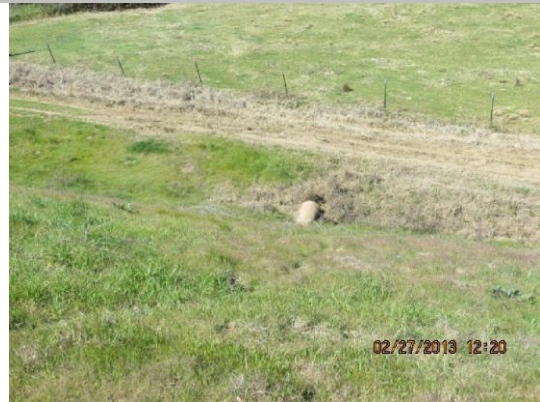
Photo 1 of 3 : UCIP\_SP\_2017\_50231\_54271.jpg

Comment Code					
Inspector Comment					
FS_ID:50231 DS_ID:22949 EP_NO: N/A Repair Type: Non-Urgent Crossing Status: Found UCIP Comments: 06/30/2016 Vegetation has been cleared at outlet enough to allow the flapgate to open by half a foot. Recommend rechecking WS outlet prior to flood season to ensure no overgrowth. Dense vegetation at LS but pipe still functional. Crossing has been downgraded from Urgent to Non-Urgent. (K. Fazel - UCIP)02/27/2013 Flap gate partially blocked by vegetation at outlet. (G. Wylie - FPIIB) FIELD_STRUCT_DESC: 18-inch corrugated metal drainage pipe through the levee, 19.5 feet below the crown. Flap gate and headwall (no headwall found in 2016) on waterside (WS). [Additional Reference(s): DWR Levee Log, 2005. USACE Sacramento O&M Manual 145, 1955 (Station 21+35). As-built dwg. 2-4-106, Sheet 2 (Station 21+35)]. Due to a recent change in the levee alignment, this pipe is no longer in Unit 6, RD0784. Nevertheless, this pipe's original references remain the RD0784 Levee Log and RD0784 USACE O&M Manual. FS Date: 6/30/2016 9:02:00 AM

Pipe at LS toe

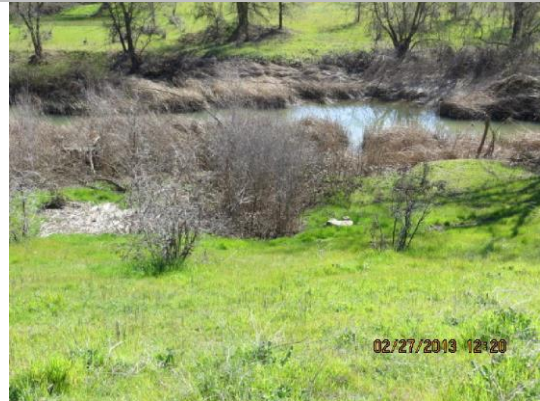
Photo 2 of 3 : UCIP\_SP\_2017\_50231\_54270.jpg

FS\_ID:50231  
DS\_ID:22949  
EP\_NO: N/A  
Repair Type: Non-Urgent  
Crossing Status: Found  
UCIP Comments: 06/30/2016 Vegetation has been cleared at outlet enough to allow the flapgate to open by half a foot. Recommend rechecking WS outlet prior to flood season to ensure no overgrowth. Dense vegetation at LS but pipe still functional. Crossing has been downgraded from Urgent to Non-Urgent. (K. Fazel - UCIP)02/27/2013 Flap gate partially blocked by vegetation at outlet. (G. Wylie - FPIIB) FIELD\_STRUCT\_DESC: 18-inch corrugated metal drainage pipe through the levee, 19.5 feet below the crown. Flap gate and headwall (no headwall found in 2016) on waterside (WS). [Additional Reference(s): DWR Levee Log, 2005. USACE Sacramento O&M Manual 145, 1955 (Station 21+35). As-built dwg. 2-4-106, Sheet 2 (Station 21+35)]. Due to a recent change in the levee alignment, this pipe is no longer in Unit 6, RD0784. Nevertheless, this pipe's original references remain the RD0784 Levee Log and RD0784 USACE O&M Manual.

Outlet in brush at WS toe.

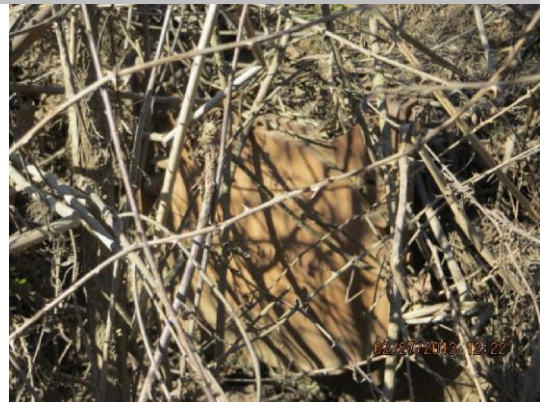
Photo 3 of 3 : UCIP\_SP\_2017\_50231\_54269.jpg

Flap gate blocked by vegetation on WS toe.

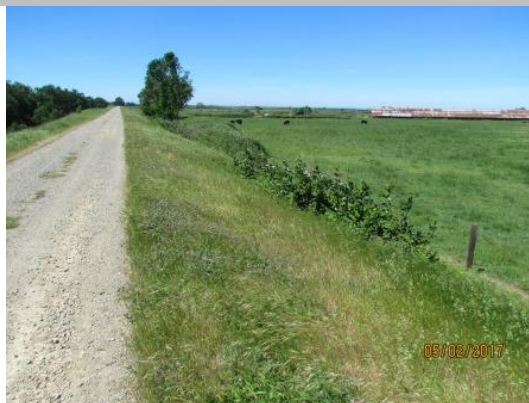
Photo 1 of 1 : SP\_2017\_RD0817\_14\_8\_20170503\_00038.jpg

View of blackberry bushes that are taking over the landside slope looking downstream. Spring 2017.

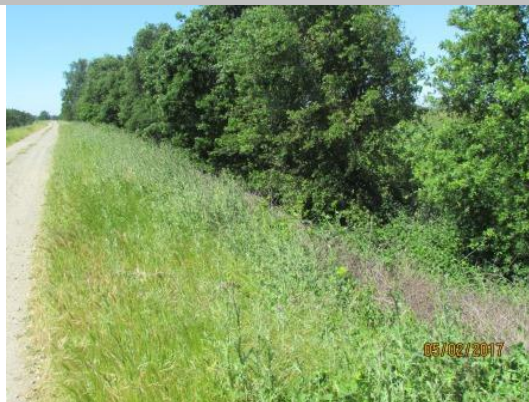
Photo 1 of 2 : SP\_2017\_RD0817\_14\_4\_20170503\_00037.jpg

LM Start	0.53	Rating **	M	Issue No.	4
LM End	0.63	Issue Type +	Ma	Location *	LS
Category	Earthen Levee			GPS Latitude/Longitude	
				Start	End
Item	Trim / Thin Trees			38.989855 °	38.990621 °
				-121.502229 °	-121.500676 °
DWR ID	DWR_RD0817_03_s_2015_4				
Comment Code					
T1 : Trim trees to at least five feet above ground level.					
Inspector Comment					
Trim tree limbs for access and visibility. Spring 2017.

View looking downstream of trees that need limbs to be trimmed for access and visibility, Spring 2017.

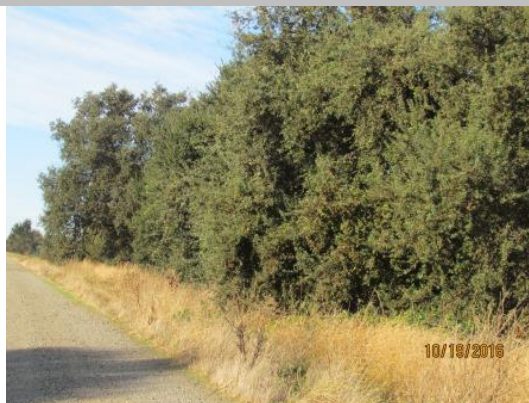
Photo 2 of 2 : SP\_2017\_RD0817\_14\_4\_20170316\_00001.jpg

View of trees that need limbs to be trimmed for access and visibility, Fall 2016.

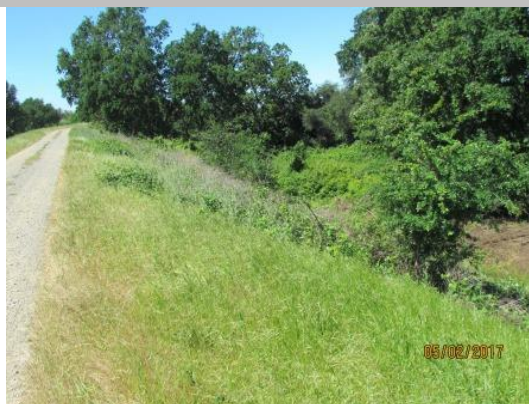
Photo 1 of 1 : SP\_2017\_RD0817\_14\_18\_20170503\_00035.jpg

LM Start	0.53	Rating **	M	Issue No.	18
LM End	0.78	Issue Type +	Ma	Location *	LS
Category	Earthen Levee			GPS Latitude/Longitude	
				Start	End
Item	Vegetation			38.989855 °	38.991990 °
				-121.502228 °	-121.498536 °
DWR ID	DWR_RD0817_03_s_2017_18				
Comment Code					
V2 : Remove the wild growth other than native grasses from the levee slopes.					
Inspector Comment					
Black Berry bushes and other wild growth are taking over landside slope and need to be removed, Spring 2017.

View looking downstream of Black Berry bushes and other wild growth that are taking over the landside slope, Spring 2017.

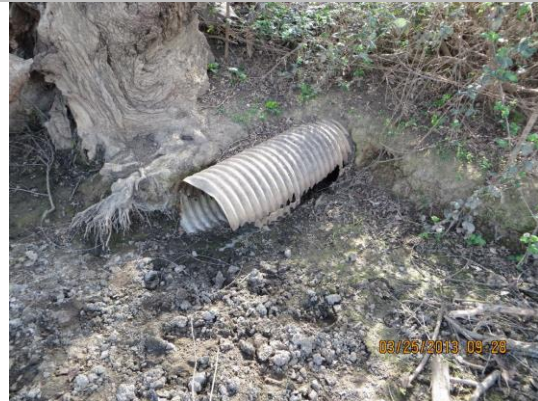
Photo 1 of 3 : UCIP\_SP\_2017\_50230\_53849.jpg

FS\_ID:50230  
DS\_ID:22950  
EP\_NO: N/A  
Repair Type: Urgent  
Crossing Status: Found  
UCIP Comments: 06/30/2016 Holes still present through pipe on corroded landside (LS) end. Pipe still half full of debris as visible thru LS end. Good candidate for removal via DWR's Deferred Maintenance Program. WS vegetation cleared in the immediate vicinity of flapgate. Potential for overgrowth at WS end nevertheless imminent. Note that this pipe does not cause LS nuisance flooding per Tom Engler of MBK. (K. Fazel - UCIP)03/25/2013 Pipe heavily corroded and failing at inlet an outlet. (G. Wylie - FPIIB)  
FIELD\_STRUCT\_DESC: 24-inch corrugated metal drainage pipe through the levee, 20.5 feet below the crown. Flap gate and headwall on the waterside (WS) end. [Additional Reference(s): DWR Levee Log, 2005. USACE Sacramento O&M Manual 145, 1955 (Station 35+57). As-built drwg 2-4-106 Sheet 4 (Station 35+57)]. Due to a recent change in the levee alignment, this pipe is no longer in Unit 6, RD0784. Nevertheless, this pipe's original references remain the RD0784 Levee Log and RD0784 USACE O&M Manual.

Pipe on LS toe corroded through.

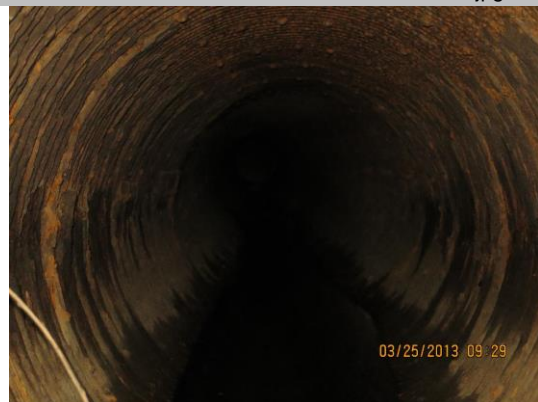
Photo 2 of 3 : UCIP\_SP\_2017\_50230\_53848.jpg

Pipe Heavily corroded throughout

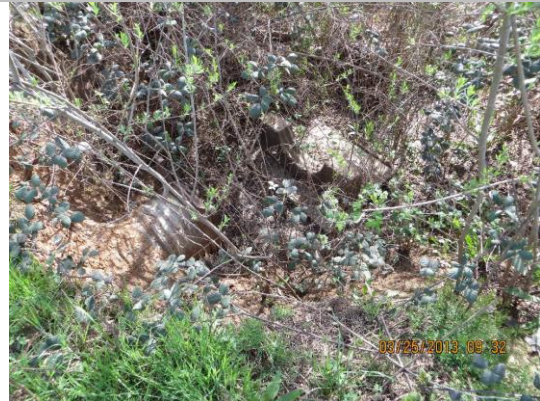
Photo 3 of 3 : UCIP\_SP\_2017\_50230\_53847.jpg

Comment Code						
Inspector Comment						
FS_ID:50230 DS_ID:22950 EP_NO: N/A Repair Type: Urgent Crossing Status: Found UCIP Comments: 06/30/2016 Holes still present through pipe on corroded landside (LS) end. Pipe still half full of debris as visible thru LS end. Good candidate for removal via DWR's Deferred Maintenance Program. WS vegetation cleared in the immediate vicinity of flapgate. Potential for overgrowth at WS end nevertheless imminent. Note that this pipe does not cause LS nuisance flooding per Tom Engler of MBK. (K. Fazel - UCIP)03/25/2013 Pipe heavily corroded and failing at inlet an outlet. (G. Wylie - FPIIB) FIELD_STRUCT_DESC: 24-inch corrugated metal drainage pipe through the levee, 20.5 feet below the crown. Flap gate and headwall on the waterside (WS) end. [Additional Reference(s): DWR Levee Log, 2005. USACE Sacramento O&M Manual 145, 1955 (Station 35+57). As-built drwg 2-4-106 Sheet 4 (Station 35+57)]. Due to a recent change in the levee alignment, this pipe is no longer in Unit 6, RD0784. Nevertheless, this pipe's original references remain the RD0784 Levee Log and RD0784 USACE O&M Manual. FS Date: 6/30/2016 9:02:00 AM

Pipe no longer mounted to headwall at WS toe.

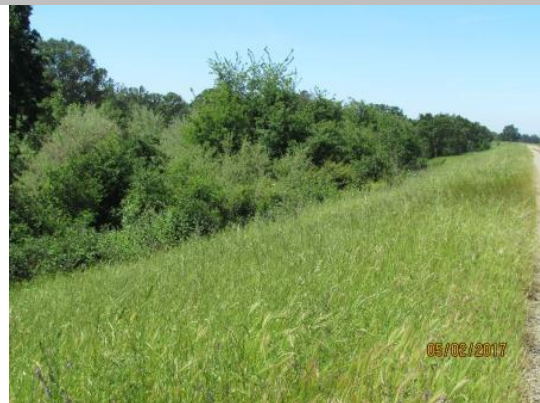
Photo 1 of 1 : SP\_2017\_RD0817\_14\_20\_20170503\_00039.jpg

LM Start	0.55	Rating **	M	Issue No.	20
LM End	0.60	Issue Type +	Ma	Location *	WS
Category	Earthen Levee			GPS Latitude/Longitude	
				Start	End
Item	Vegetation			38.989976 °	38.990403 °
				-121.501970 °	-121.501110 °
DWR ID	DWR_RD0817_03_s_2017_20				
Comment Code					
V2 : Remove the wild growth other than native grasses from the levee slopes.					
Inspector Comment					
Trees and dense bushes need to be remove from levee slope, Spring 2017.

View looking downstream of trees and bushes that block the view of the levee slope, Spring 2017.

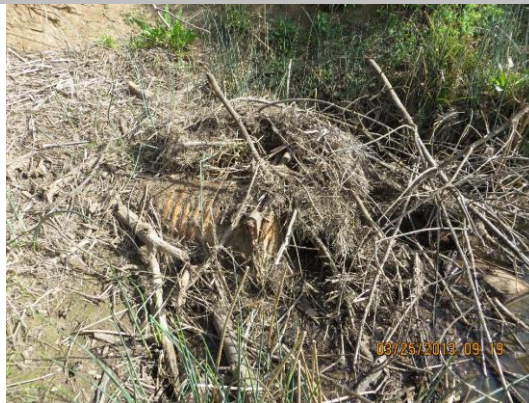
Photo 1 of 3 : UCIP\_SP\_2017\_50232\_53854.jpg

FS\_ID:50232  
DS\_ID:22951  
EP\_NO: N/A  
Repair Type: Urgent  
Crossing Status: Found  
UCIP Comments: 06/30/2016 Corrosion still present on WS end. Inlet box was replaced 5 years ago and appears to be functioning properly due to the presence of a screen that prevents debris blockage. Flap gate functions properly only sometimes. WS heavily vegetated. (K. Fazel - UCIP) 03/25/2013 Corrosion holes on WS toe and flap gate is blocked by debris. Flap gate broken. Inlet partially blocked at concrete inlet. (G. Wylie - FPIIB)  
FIELD\_STRUCT\_DESC: 24-inch corrugated metal drainage pipe through the levee, 20 feet below the crown. Flap gate and headwall on the waterside (WS). 56 by 34-inch concrete inlet box on the landside (LS) toe. [Additional Reference(s): DWR Levee Log, 2005. USACE Sacramento O&M Manual 145, 1955 (Station 43+17). As-built drwg. 2-4-106 Sheet 4 (Station 43+17)]. Due to a recent change in the levee alignment, this pipe is no longer in Unit 6, RD0784. Nevertheless, this pipe's original references remain the RD0784 Levee Log and RD0784 USACE O&M Manual.

Pipe and flapgate at WS toe blocked by debris.

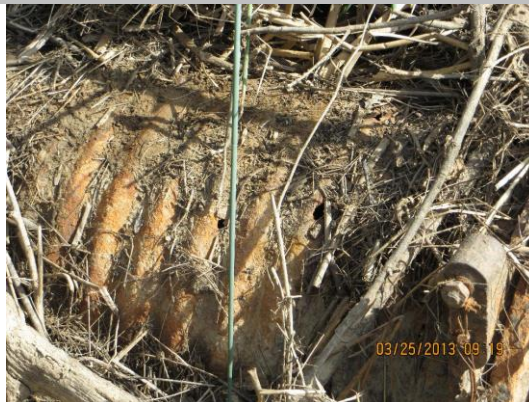
Photo 2 of 3 : UCIP\_SP\_2017\_50232\_53853.jpg

Holes in pipe at broken flapgate on WS toe.

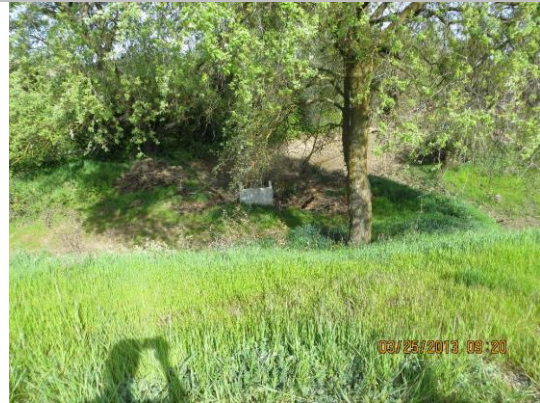
Photo 3 of 3 : UCIP\_SP\_2017\_50232\_53852.jpg

Comment Code					
Inspector Comment					
FS_ID:50232 DS_ID:22951 EP_NO: N/A Repair Type: Urgent Crossing Status: Found UCIP Comments: 06/30/2016 Corrosion still present on WS end. Inlet box was replaced 5 years ago and appears to be functioning properly due to the presence of a screen that prevents debris blockage. Flap gate functions properly only sometimes. WS heavily vegetated. (K. Fazel - UCIP) 03/25/2013 Corrosion holes on WS toe and flap gate is blocked by debris. Flap gate broken. Inlet partially blocked at concrete inlet. (G. Wylie - FPIIB) FIELD_STRUCT_DESC: 24-inch corrugated metal drainage pipe through the levee, 20 feet below the crown. Flap gate and headwall on the waterside (WS). 56 by 34-inch concrete inlet box on the landside (LS) toe. [Additional Reference(s): DWR Levee Log, 2005. USACE Sacramento O&M Manual 145, 1955 (Station 43+17). As-built drwg. 2-4-106 Sheet 4 (Station 43+17)]. Due to a recent change in the levee alignment, this pipe is no longer in Unit 6, RD0784. Nevertheless, this pipe's original references remain the RD0784 Levee Log and RD0784 USACE O&M Manual. FS Date: 6/30/2016 9:03:00 AM

Improvised concrete inlet on LS toe.

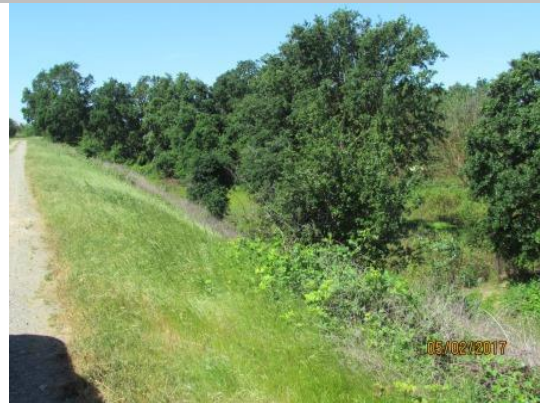
Photo 1 of 2 : SP\_2017\_RD0817\_14\_19\_20170503\_00034.jpg

View of trees that need limbs to be trimmed for access and visibility, Spring 2017.

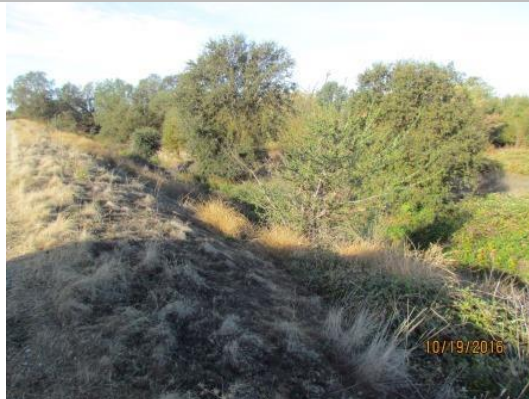
Photo 2 of 2 : SP\_2017\_RD0817\_14\_19\_20170316\_00010.jpg

View of trees that need limbs to be trimmed for access and visibility, Fall 2016.

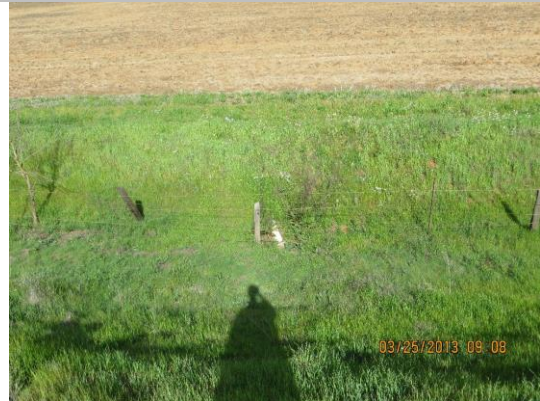
Photo 1 of 3 : UCIP\_SP\_2017\_50234\_53857.jpg

FS\_ID:50234  
DS\_ID:22952  
EP\_NO: N/A  
Repair Type: Urgent  
Crossing Status: Found  
UCIP Comments: 06/30/2016 Same as last inspection. Good candidate for removal via DWR's Deferred Maintenance Program. Pipe used to drain pastureland which have since been converted to rice fields that drain on opposite side of fields, rendering the drainage function of this pipe obsolete. This pipe is not needed and causes nuisance flooding at high water on landside (LS) per Tom Engler of MBK. As such, operation of flapgate is still blocked via a post at WS end. Pipe is sleeved but sleeve has grossly deteriorated. LS end of pipe appears bent. (K. Fazel - UCIP)03/25/2013 Pipe heavily corroded and damaged. 8-inch PVC pipe runs through pipe/possibly for irrigation. CMP heavily rusted on WS toe and debris blocking flap gate on WS toe. (G. Wylie - FPIIB) FIELD\_STRUCT\_DESC: \*ABANDONED\* 20-inch (not 18-inch as referenced in the O&M Manual) corrugated metal drainage pipe through the levee, 16.5 feet below the crown. 8-inch polyvinyl chloride (PVC) pipe sleeved through the 20-inch pipe with annular space left void. Flap gate on the waterside (WS). [Additional Reference(s): DWR Levee Log, 2005. USACE Sacramento O&M Manual 145, 1955 (Station 69+17). As-built drwg. 2-4-106 Sheet 4 (Station 69+17)]. Due to a recent change in the levee alignment, this pipe is no longer in Unit 6, RD0784. Nevertheless, this pipe's original references remain the RD0784 Levee Log and RD0784 USACE O&M Manual.

Pipe on LS toe with 8-inch PVC pipe sticking out.

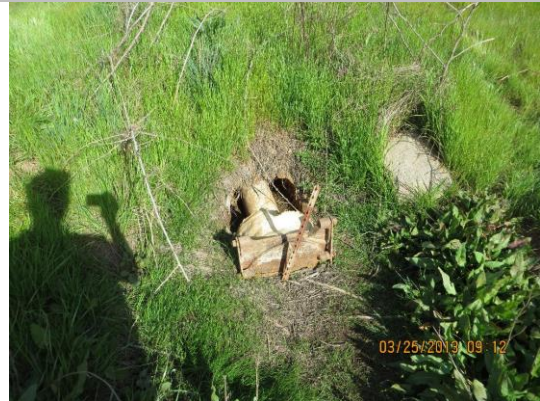
Photo 2 of 3 : UCIP\_SP\_2017\_50234\_53856.jpg

FS\_ID:50234  
DS\_ID:22952  
EP\_NO: N/A  
Repair Type: Urgent  
Crossing Status: Found  
UCIP Comments: 06/30/2016 Same as last inspection. Good candidate for removal via DWR's Deferred Maintenance Program. Pipe used to drain pastureland which have since been converted to rice fields that drain on opposite side of fields, rendering the drainage function of this pipe obsolete. This pipe is not needed and causes nuisance flooding at high water on landside (LS) per Tom Engler of MBK. As such, operation of flapgate is still blocked via a post at WS end. Pipe is sleeved but sleeve has grossly deteriorated. LS end of pipe appears bent. (K. Fazel - UCIP)03/25/2013 Pipe heavily corroded and damaged. 8-inch PVC pipe runs through pipe/possibly for irrigation. CMP heavily rusted on WS toe and debris blocking flap gate on WS toe. (G. Wylie - FPIIB) FIELD\_STRUCT\_DESC: \*ABANDONED\* 20-inch (not 18-inch as referenced in the O&M Manual) corrugated metal drainage pipe through the levee, 16.5 feet below the crown. 8-inch polyvinyl chloride (PVC) pipe sleeved through the 20-inch pipe with annular space left void. Flap gate on the waterside (WS). [Additional Reference(s): DWR Levee Log, 2005. USACE Sacramento O&M Manual 145, 1955 (Station 69+17). As-built drwg. 2-4-106 Sheet 4 (Station 69+17)]. Due to a recent change in the levee alignment, this pipe is no longer in Unit 6, RD0784. Nevertheless, this pipe's original references remain the RD0784 Levee Log and RD0784 USACE O&M Manual.

Pipe cut behind flap gate on WS toe with 8-inch PVC.

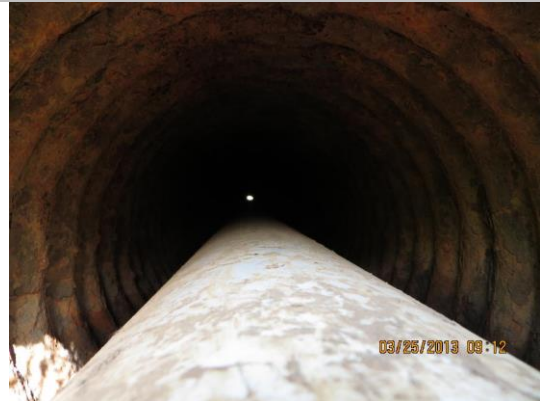
Photo 3 of 3 : UCIP\_SP\_2017\_50234\_53855.jpg

FS\_ID:50234  
DS\_ID:22952  
EP\_NO: N/A  
Repair Type: Urgent  
Crossing Status: Found  
UCIP Comments: 06/30/2016 Same as last inspection. Good candidate for removal via DWR's Deferred Maintenance Program. Pipe used to drain pastureland which have since been converted to rice fields that drain on opposite side of fields, rendering the drainage function of this pipe obsolete. This pipe is not needed and causes nuisance flooding at high water on landside (LS) per Tom Engler of MBK. As such, operation of flapgate is still blocked via a post at WS end. Pipe is sleeved but sleeve has grossly deteriorated. LS end of pipe appears bent. (K. Fazel - UCIP)03/25/2013 Pipe heavily corroded and damaged. 8-inch PVC pipe runs through pipe/possibly for irrigation. CMP heavily rusted on WS toe and debris blocking flap gate on WS toe. (G. Wylie - FPIIB) FIELD\_STRUCT\_DESC: \*ABANDONED\* 20-inch (not 18-inch as referenced in the O&M Manual) corrugated metal drainage pipe through the levee, 16.5 feet below the crown. 8-inch polyvinyl chloride (PVC) pipe sleeved through the 20-inch pipe with annular space left void. Flap gate on the waterside (WS). [Additional Reference(s): DWR Levee Log, 2005. USACE Sacramento O&M Manual 145, 1955 (Station 69+17). As-built drwg. 2-4-106 Sheet 4 (Station 69+17)]. Due to a recent change in the levee alignment, this pipe is no longer in Unit 6, RD0784. Nevertheless, this pipe's original references remain the RD0784 Levee Log and RD0784 USACE O&M Manual.

Pipe heavily corroded throughout.

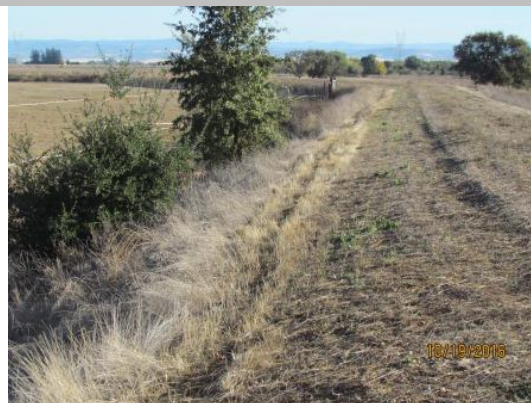
Photo 1 of 1 : SP\_2017\_RD0817\_14\_12\_20170316\_00003.jpg

View of annual grasses on the landside looking upstream.

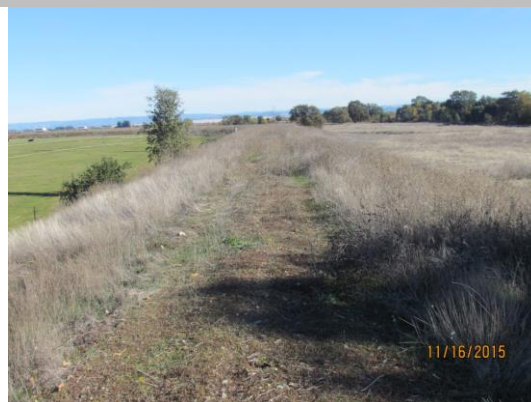
Photo 1 of 2 : SP\_2017\_RD0817\_14\_14\_20170316\_00005.jpg

View of the vegetation on the crown of the levee looking upstream.

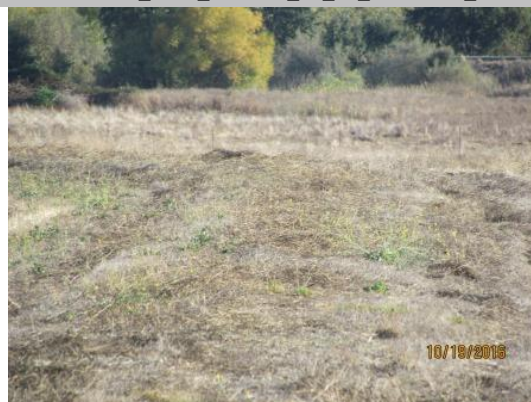
Photo 2 of 2 : SP\_2017\_RD0817\_14\_14\_20170316\_00006.jpg

View of the vegetation on the crown of the levee looking upstream. Fall 2016.

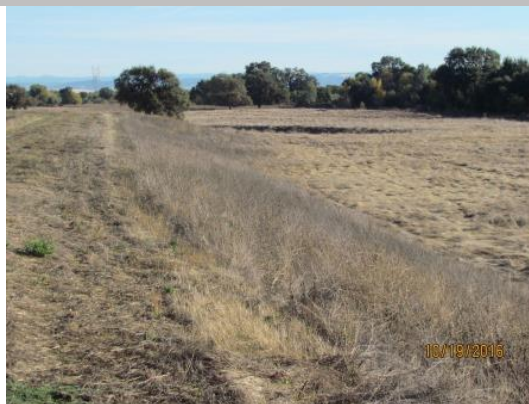
Photo 1 of 1 : SP\_2017\_RD0817\_14\_13\_20170316\_00004.jpg

Fall 2016 View of waterside looking upstream.

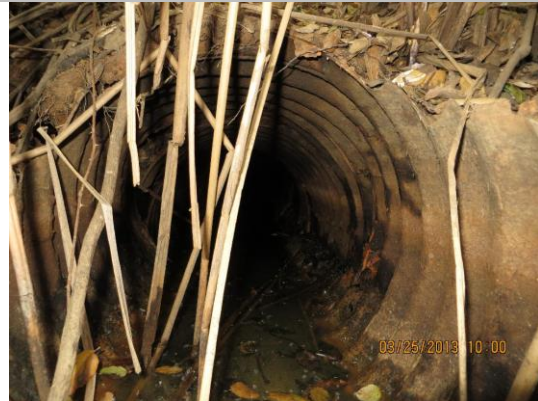
Photo 1 of 3 : UCIP\_SP\_2017\_50235\_53859.jpg

FS\_ID:50235  
DS\_ID:22953  
EP\_NO: N/A  
Repair Type: Urgent  
Crossing Status: Found  
UCIP Comments: 06/30/2016 Sink hole still exists over pipe on LS. LS and WS heavily vegetated and barely accessible. WS end is sleeved with a heavily rusted CMP. Flapgate is clear and functional. (K. Fazel - UCIP)12/17/2015 WS accessible, but LS no longer accessible due to heavy vegetation. (T. Hatch - UCIP)03/25/2013 Pipe visible on LS at toe of roadway embankment, but not visible on WS. Possible sinkhole over pipe at LS toe. Pipe heavily rusted. (G. Wylie - FPIIB)  
FIELD\_STRUCT\_DESC: 18-inch corrugated metal drainage pipe (CMP) angled through the levee, approximately 15 feet below the crown. Steel pipe sleeved through the CMP with annular space grouted (grout only on the waterside (WS)). Flap gate on the WS end. Pipe alignment is from the west of the intersection of 40 Mile Road and 45 degrees to the WS. Outlet is on the eastern side of 40 Mile Rd (looking upstream).

Pipe at inlet on LS toe.

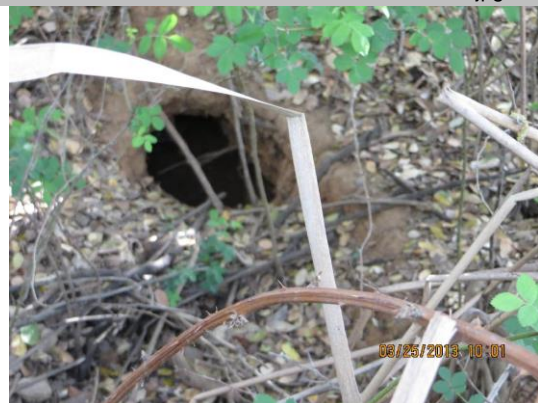
Photo 2 of 3 : UCIP\_SP\_2017\_50235\_53858.jpg

Sinkhole or animal burrow over pipe on LS toe.

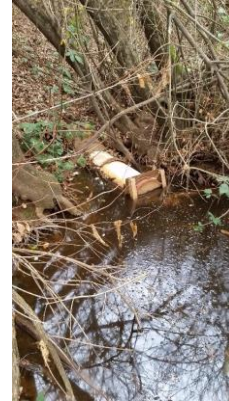
Photo 3 of 3 : UCIP\_SP\_2017\_50235\_74804.jpg

WS drainage outlet with flap gate. Steel pipe is sleeved within heavily rusted CM pipe near daylight to embankment
